Work Order: KSI-024-110

St. Stephen Martyr Church
64 W Arlington Drive,
Dowling, ON
POM 1R0

1. Introduction

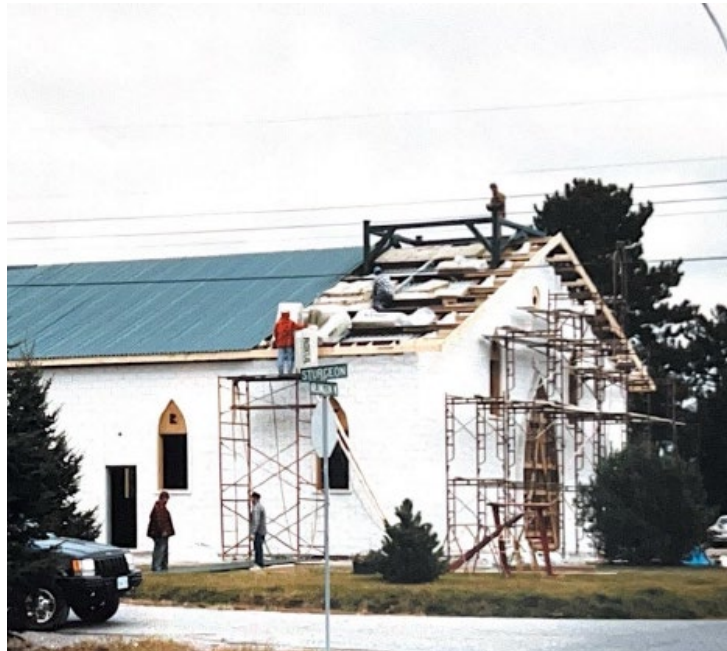
1. Metal roofing was installed on the building around the steel framing of the bell tower (*Figure 1*).
2. There is no flashing around the steel columns supporting the bell tower (*Figure 2*).
3. At the time of installation, there were no snow stops installed to the metal roofing (*Figure 2*).

When the building was renovated in 1998, it was finished with metal roofing. The support structure was installed before the metal roofing was installed as seen in *Figure 1*. Due to the order of construction, the metal roofing would have been cut to fit around the steel columns. This method of installation is susceptible to leaking at the seam where the roofing was cut if not sealed and flashed properly. In *Figures 1-2*, there is no flashing visible around the steel supports for the bell tower.

Figure 1 - Installation of metal roof (1998)

Komri Engineering suggests having a competent contractor repair the metal roofing to ensure proper installation and no leaks as well as provide adequate flashing in all locations, especially around the bell tower. This contractor shall be experienced and provide Komri Engineering information about the existing roof to ensure that water damage has not extended to cause structural concern. During the repairs, Komri Engineering or another licensed professional engineer shall be retained to ensure the adequacy of the structure to keep performing.

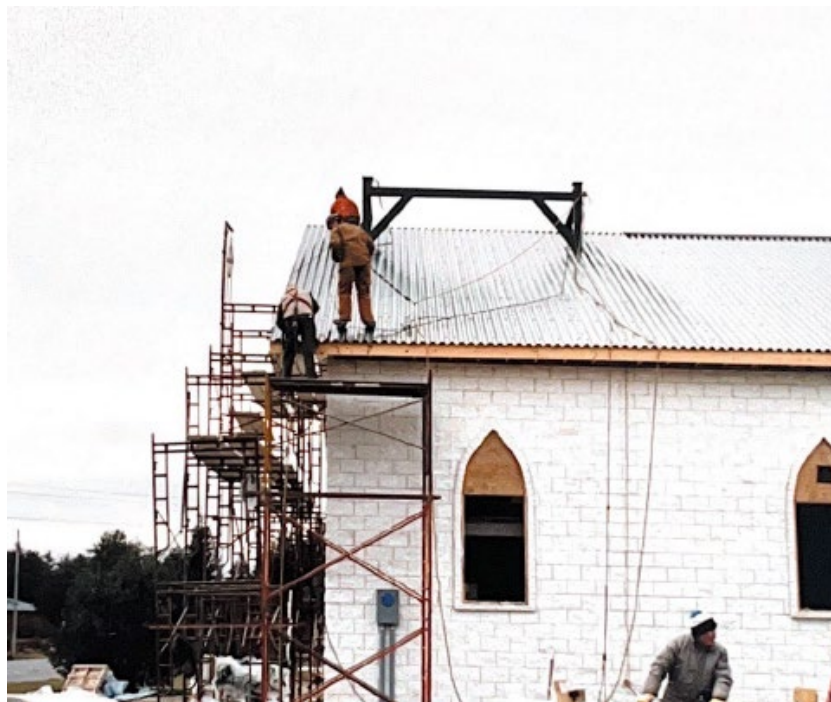
Figure 2 - Installation of metal roof (1998)

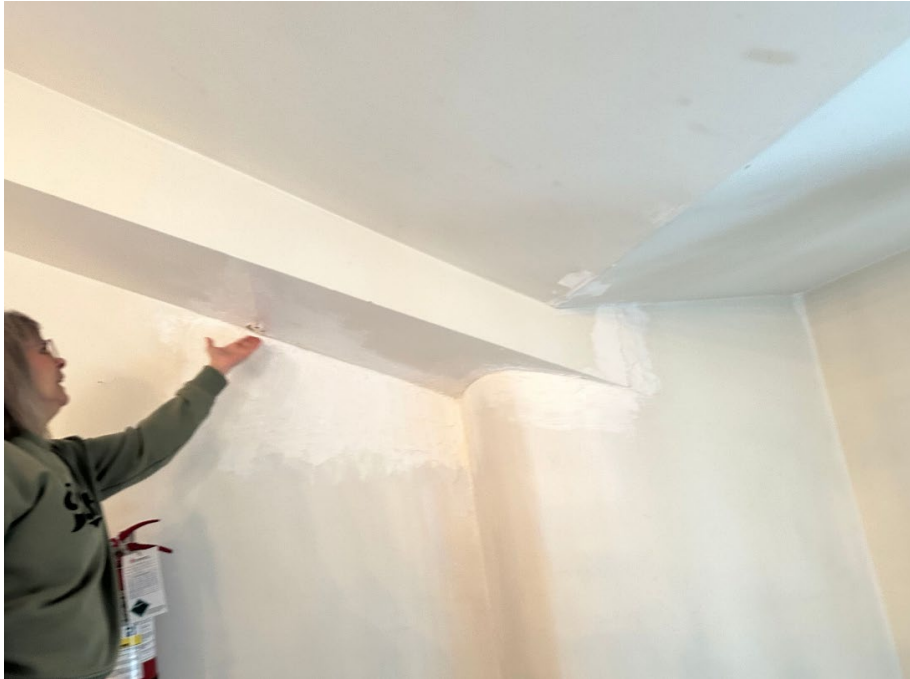
1. There was no visible flashing installed around the 8" steel columns which support the bell tower.
2. The building had snow stops installed to prevent snow and ice from sliding off the roof.
3. Water damage was visible in multiple spots in the south of the building beneath the bell tower (*Figures 3-8*).
4. There is a crack in the gypsum board at the ridge and various locations of the building (*Figure 9*).

When discussing with the client on site, it was mentioned that the building began to leak shortly after the renovations were completed in 1999. The leaks have historically been concentrated in the southern end of the building, close to the steel columns which support the bell tower. Due to the continuity of the channels through the roofing, there is reasonable likelihood that many of the leaks in the metal roofing stem from this area.

Figure 3 - Previous repair / leak in south-east corner of church

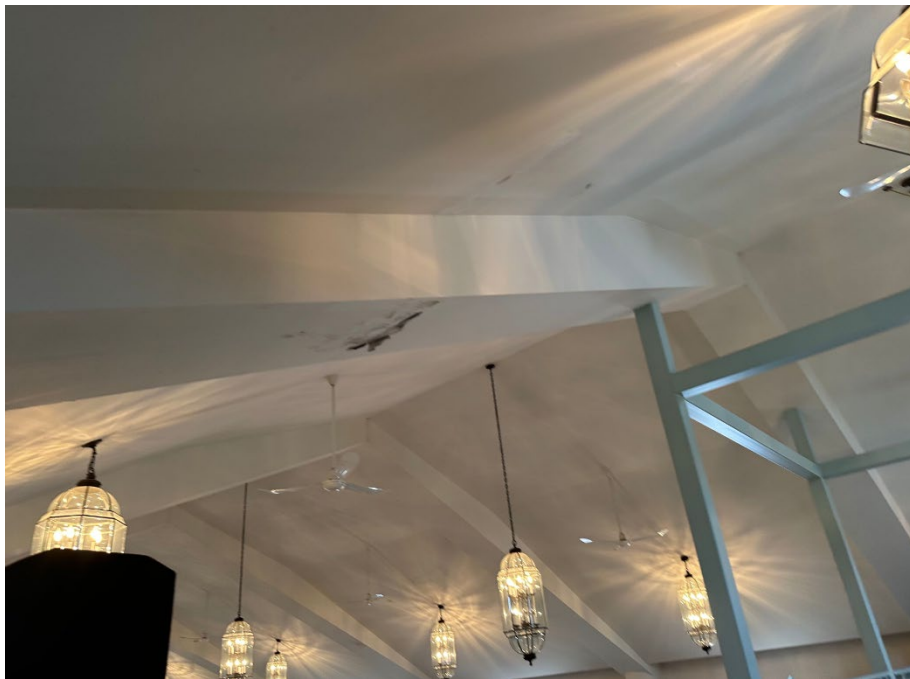
Figure 4 - Previous repair / leak in south-west corner of church

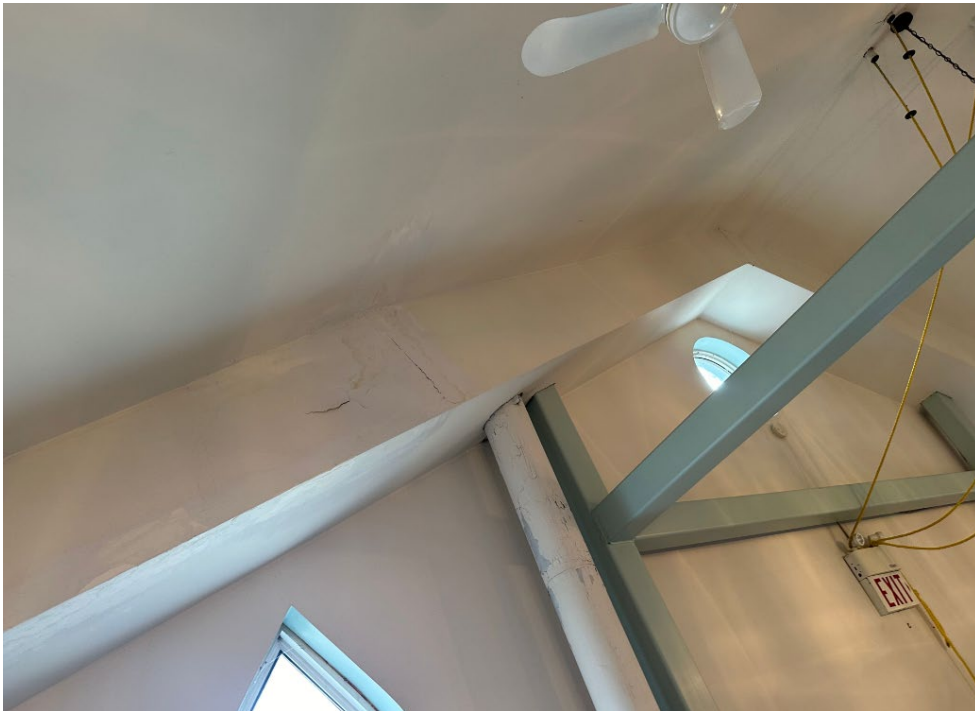
Figure 5 - Previous repair / leak on south wall of church

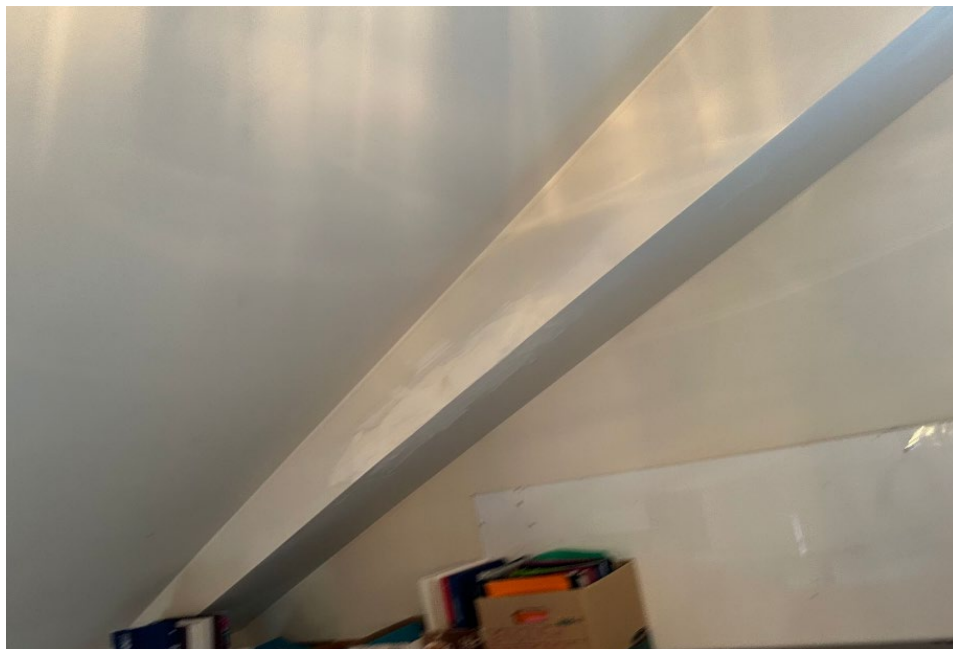
Figure 6 - Previous repair / leak on south wall of church

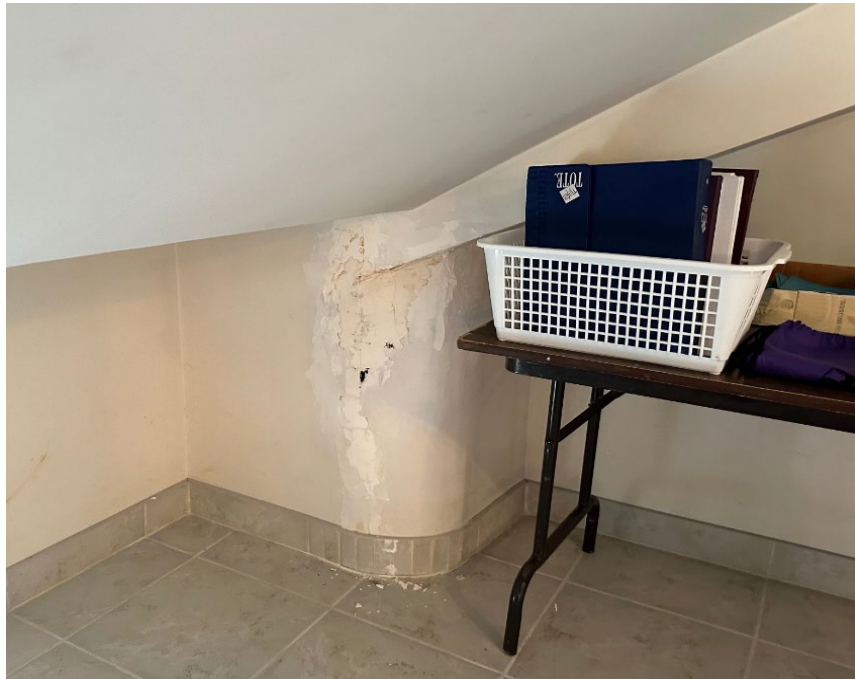
Figure 7 - Previous repair / leak in south-east corner of church

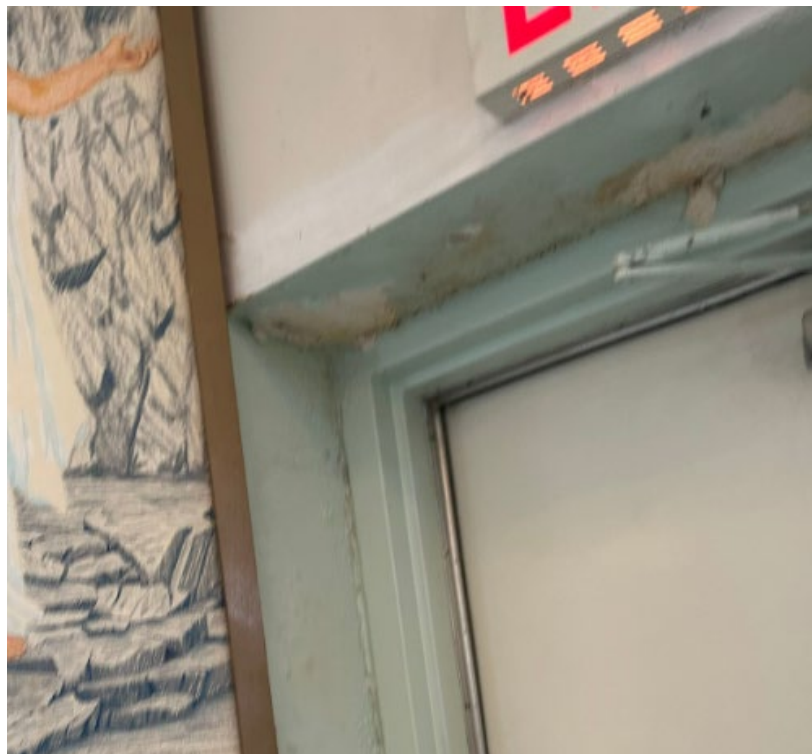
Figure 8 - Previous repair / leak at emergency exit of church

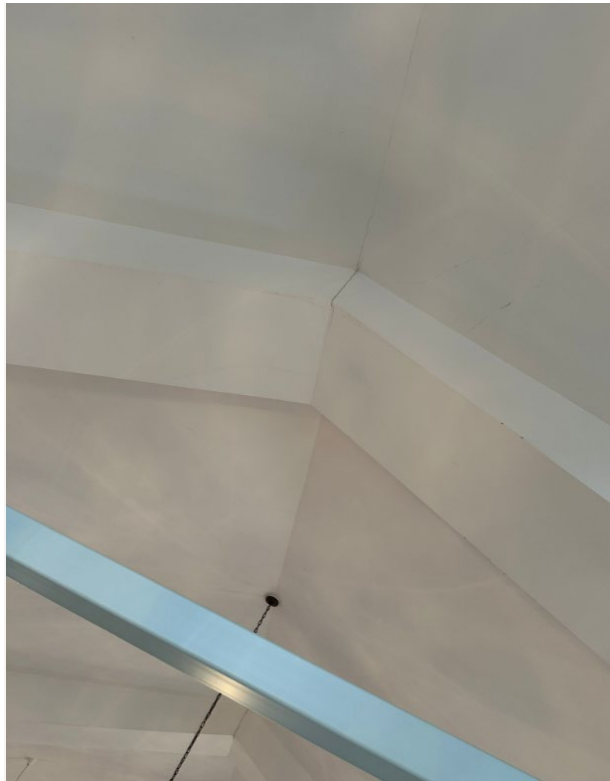
A crack was observed at the peak of the roof on the interior of the church, although not visible while on site, it was mentioned that the crack extends the length of the building. Without removing some of the interior finish it is difficult to determine the origin of the crack.

Figure 9 - Crack at ridge of building
